NATIONAL TRANSPORTATION SAFETY BOARD

RAILROAD ACCIDENT REPORT

DERAILMENT OF SOUTHERN RAILWAY COMPANY
TRAIN NO. 2, THE CRESCENT

NTSB-RAR-79-4

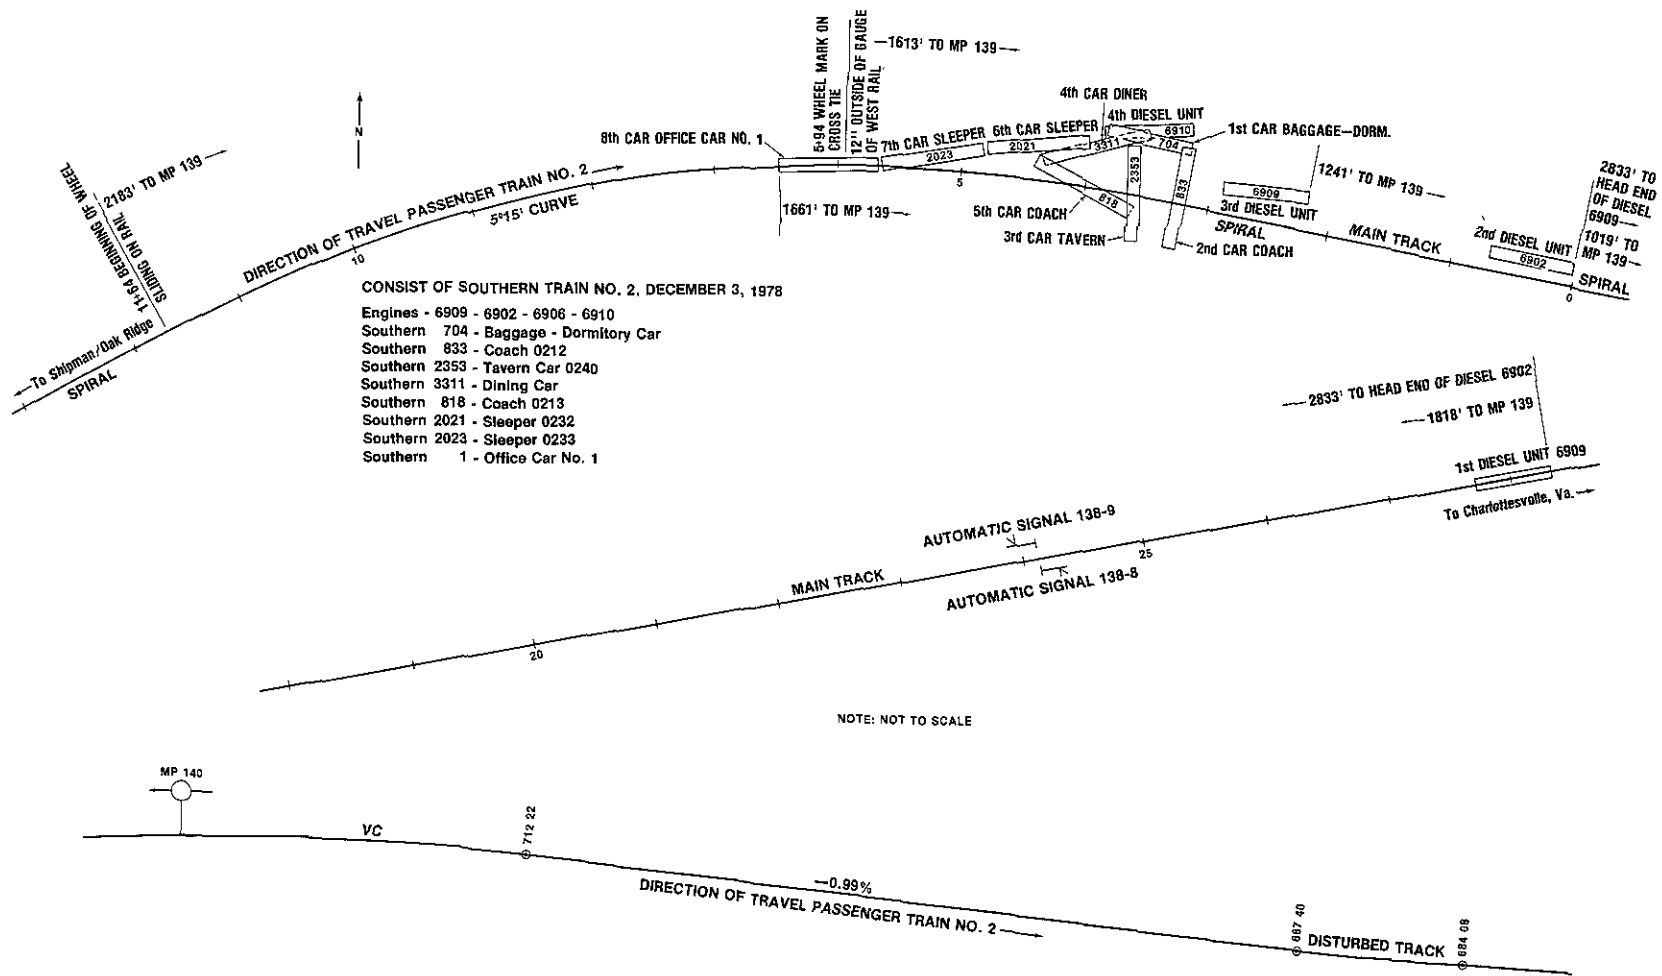
Figure 1. Plan of accident site.

The engineer continued to probe the shunt field contactor, and when he turned to observe the track to determine his location he saw that he was approaching a 5°15' curve which had a 45-mph speed limit. He knew that the train's speed was too fast to move around the curve, and he immediately made a service brake application, followed almost in a continuing move by an emergency application. The train derailed after moving about 570 feet into the 800-foot curve. (See figure 1.)

The lead unit separated from the other three locomotive units and continued northward 3,427 feet. The second and third units turned on their sides and stopped 594 feet and 372 feet respectively, from the point of the derailment along the west side of the track. The fourth unit buried itself in a dirt embankment at the end of a ravine, 285 feet

from the derailment point and 64 feet west of the track. Its trajectory was nearly tangential from the derailment point to where it stopped in the bank.

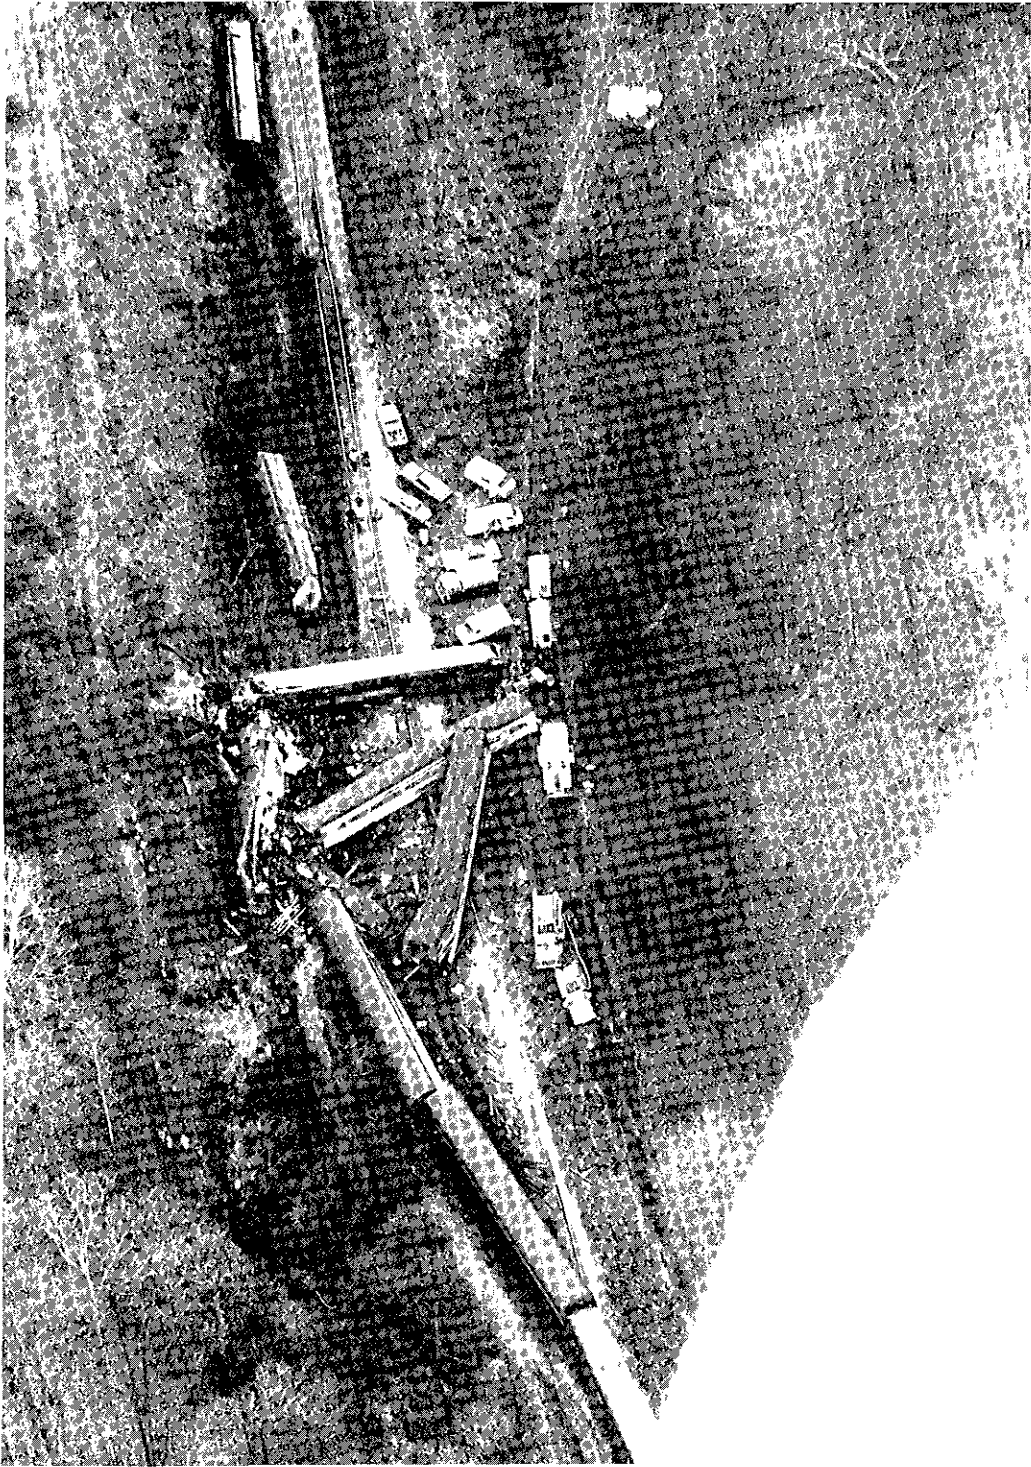
Figure 2. Aerial view of accident site.

The fourth locomotive unit and seven cars were contained in a 250-foot distance. Some cars overrode each other, while others jackknifed across the track. The first, a baggage car, was overturned and stopped on top of the fourth unit. The second car, a coach, was turned on its right side and was lying across the track. The third, a tavern car, jackknifed and stopped across the track. The fourth car, a diner, went into the ravine and was partially overridden by other cars. The fifth car, a coach, stopped across the track. The sixth and seventh, sleeping cars, were stopped on the side of the fill headed into the ravine, and the eighth, a business car, stopped on the track structure. (See figure 2.)

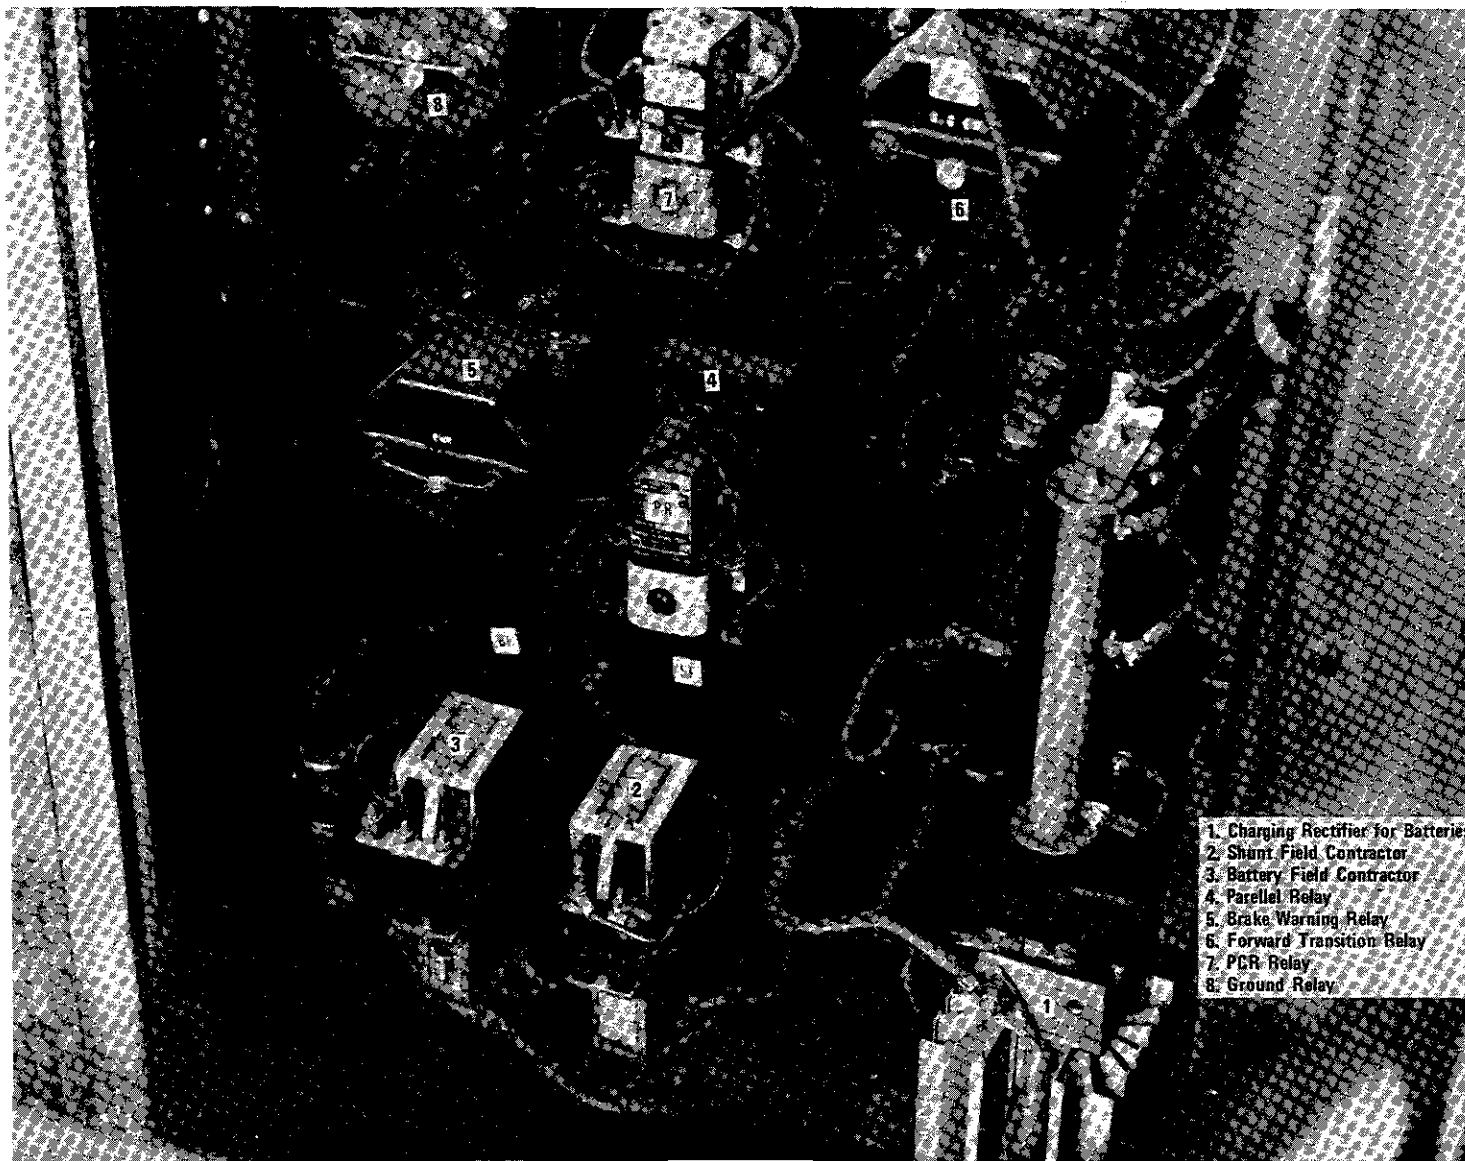
Figure 3. Interior view of low voltage cabinet.

Two cabinets which contained electrical components were located in the rear of the operating compartment. One, a high voltage cabinet, was kept locked. The other, a low voltage cabinet, was not locked and contained fuses and other equipment for use of the enginecrew. The low voltage cabinet also contained the shunt field and the battery field contactors, and other relays associated with transition. (See figure 3.)

1. Charging Rectifier for Batteries
2. Shunt Field Contractor
3. Battery Field Contractor
4. Parallel Relay
5. Brake Warning Relay
6. Forward Transition Relay
7. PCR Relay
8. Ground Relay

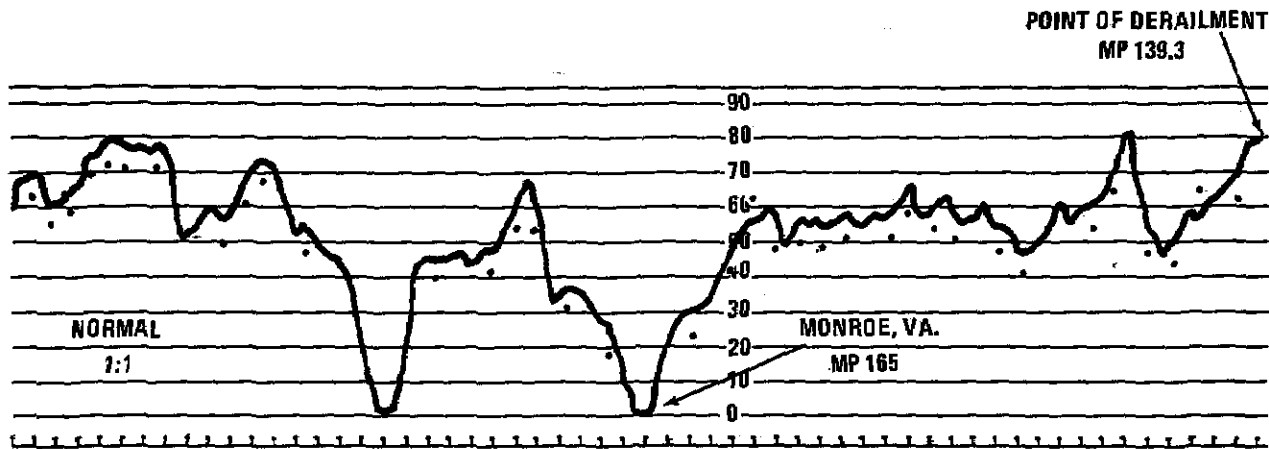
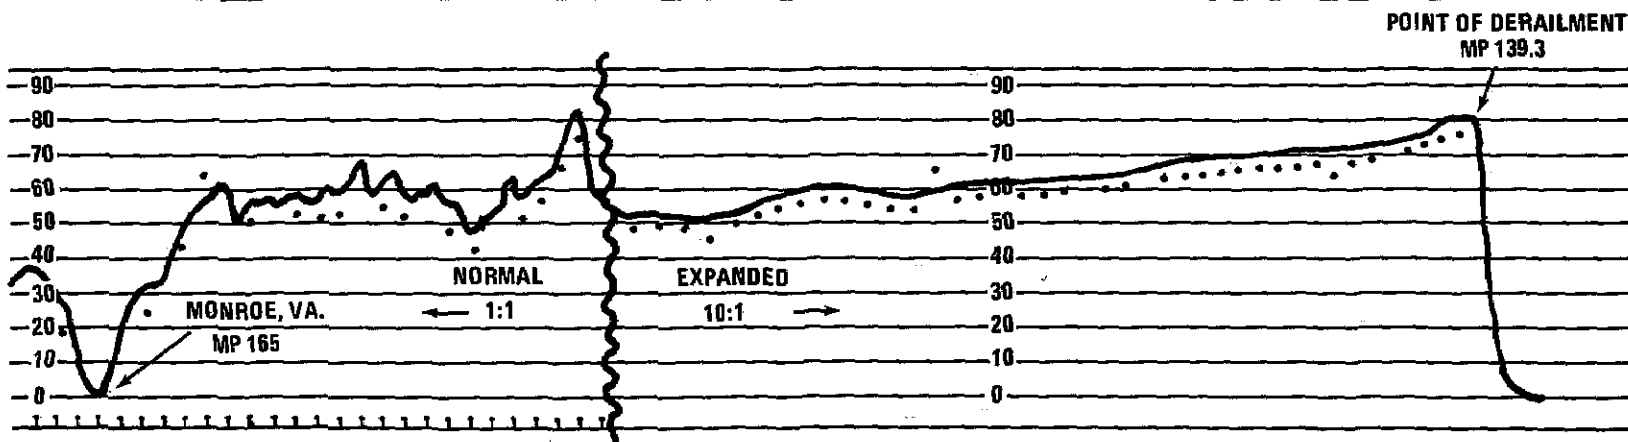
LOCOMOTIVE NO. 6902

The four locomotive units were provided with speed recorder units. The recorder uses a standard 8-track tape cassette. The first locomotive unit had a defective recorder and no speed data was recorded. The three cassettes from the other locomotive units were processed and a tape produced. All three units recorded similar data. They showed stops at Lynchburg, Virginia and Monroe; they showed the slow speed of 50 mph required at Tye River and Oakridge for the equilateral turnouts; they showed the reduction in throttle made by the engineer when he was attempting to clear the locomotive's failure to make transition; and they showed a gradual acceleration from Oakridge to 80 mph at the point of derailment. There was no data recorded following the derailment. (See Appendix D.)

AREA OF DERAILMENT
CARTRIDGE OUT OF RECORDER
LAST SPEED DATA LOST
